DEPARTMENT OF TRANSPORTATION**DIVISION OF ENGINEERING SERVICES**

Contract #: 04-0120F4Cty: SF/ALA Rte: 80 PM: 13.2/13.9File #: 13.28**WELDING INSPECTION REPORT****Resident Engineer:**Pursell, Gary**Address:** 333 Burma Road**City:** Oakland, CA 94607**Report No:** WIR-006406**Date Inspected:** 24-Apr-2009**Project Name:** SAS Superstructure**OSM Arrival Time:** 700**Prime Contractor:** American Bridge/Fluor Enterprises, a JV**OSM Departure Time:** 1530**Contractor:** Oregon Iron Works Clackamas, Or.**Location:** Clackamas, OR**CWI Name:** Mike Gregson, Rob Walters**CWI Present:** Yes No**Inspected CWI report:** Yes No N/A**Rod Oven in Use:** Yes No N/A**Electrode to specification:** Yes No N/A**Weld Procedures Followed:** Yes No N/A**Qualified Welders:** Yes No N/A**Verified Joint Fit-up:** Yes No N/A**Approved Drawings:** Yes No N/A**Approved WPS:** Yes No N/A**Delayed / Cancelled:** Yes No N/A**Bridge No:** 34-0006**Component:** Hinge K Pipe Beams**Summary of Items Observed:**

OIW Fabrication Shop-Bay 3**Hinge-K Pipe Beam Assembly 102A-1: 4/24/09****a111-1 Forging to a110-1 Base Plate**

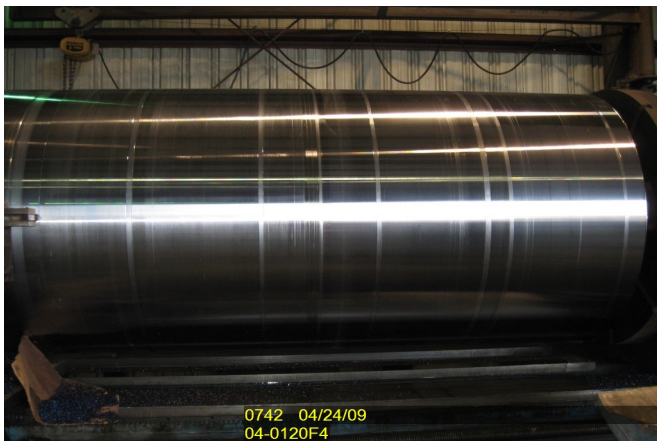
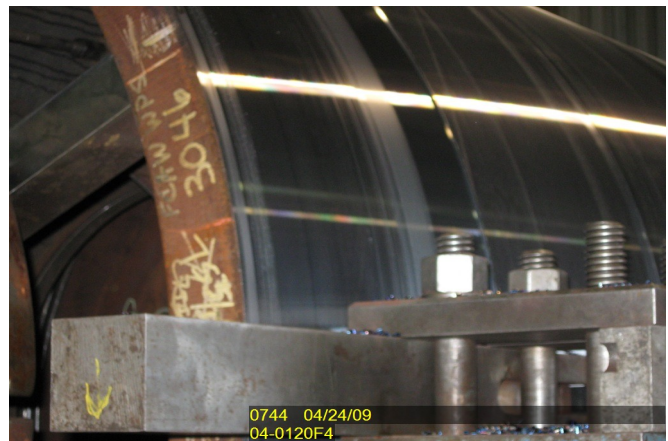
QA Inspector noticed that A & G Machining had completed the second machining cut pass of .150" (3.8mm) and the third, final pass of .160" (4mm) was in-progress.

A&G Machining explained to QA Inspector that this final cut pass should be completed sometime Monday (4/27/09) and are targeting to finish with a 1903mm diameter. See attached pictures.....
